Exhibit A

Through Process Asbestos Destruction Samples: Taken in 15 min intervals. Microscopy and Photos Done at the ABVOV® Pilot Plant by Chaiyut Sae Lao, EMS Analytical, Inc.

Destruction Progression- Initial Phase

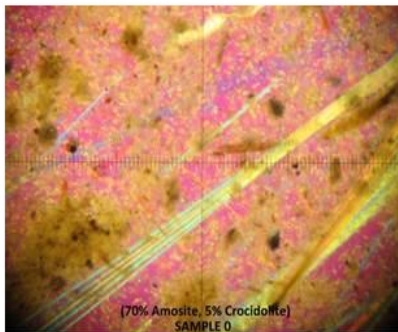
Sample 0: 70% Amosite, 5% Crocidolite **Sample 1: 70% Amosite, 5% Crocidolite**

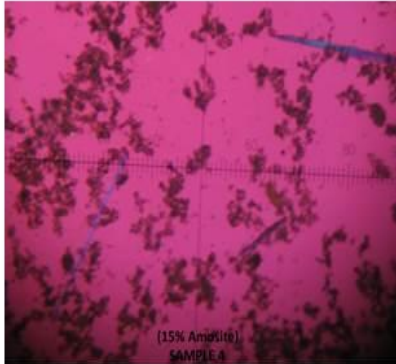
Sample 4: 15% Amosite

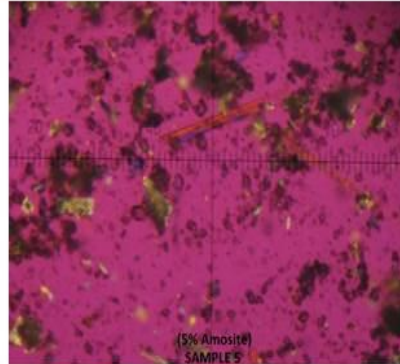
Sample 5: 5% Amosite

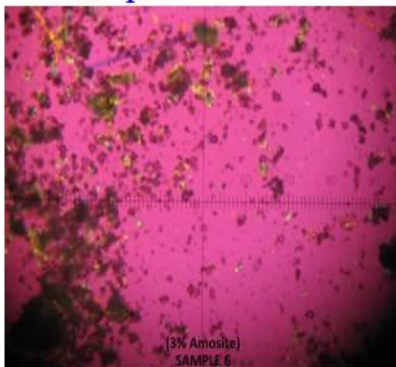
Sample 6: 3% Amosite

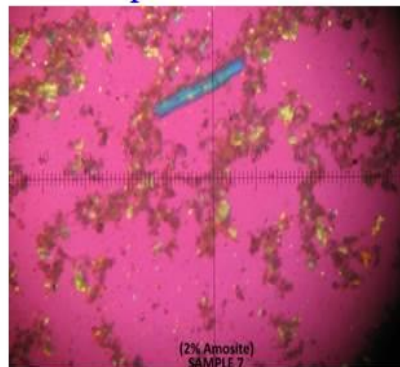
Sample 7: 2% Amosite

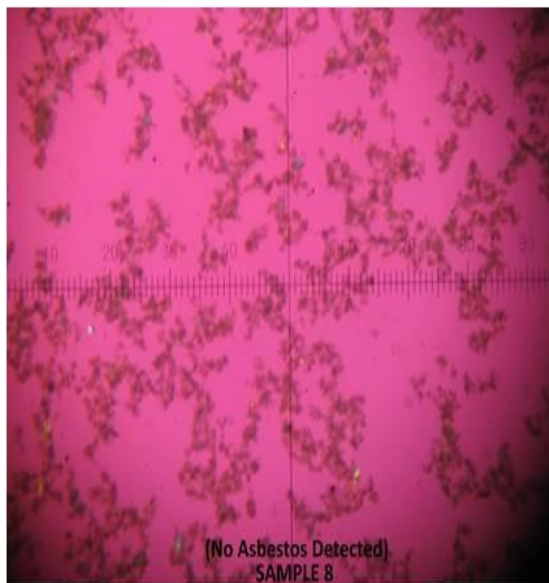
Total Destruction of Asbestos-
Process Completed

Sample 8: No Asbestos Detected
