United States  
Environmental Protection  
Agency

EPA/600/R-02/099  
December 2002

# Assessment and Recommendations for Improving the Performance of Waste Containment Systems

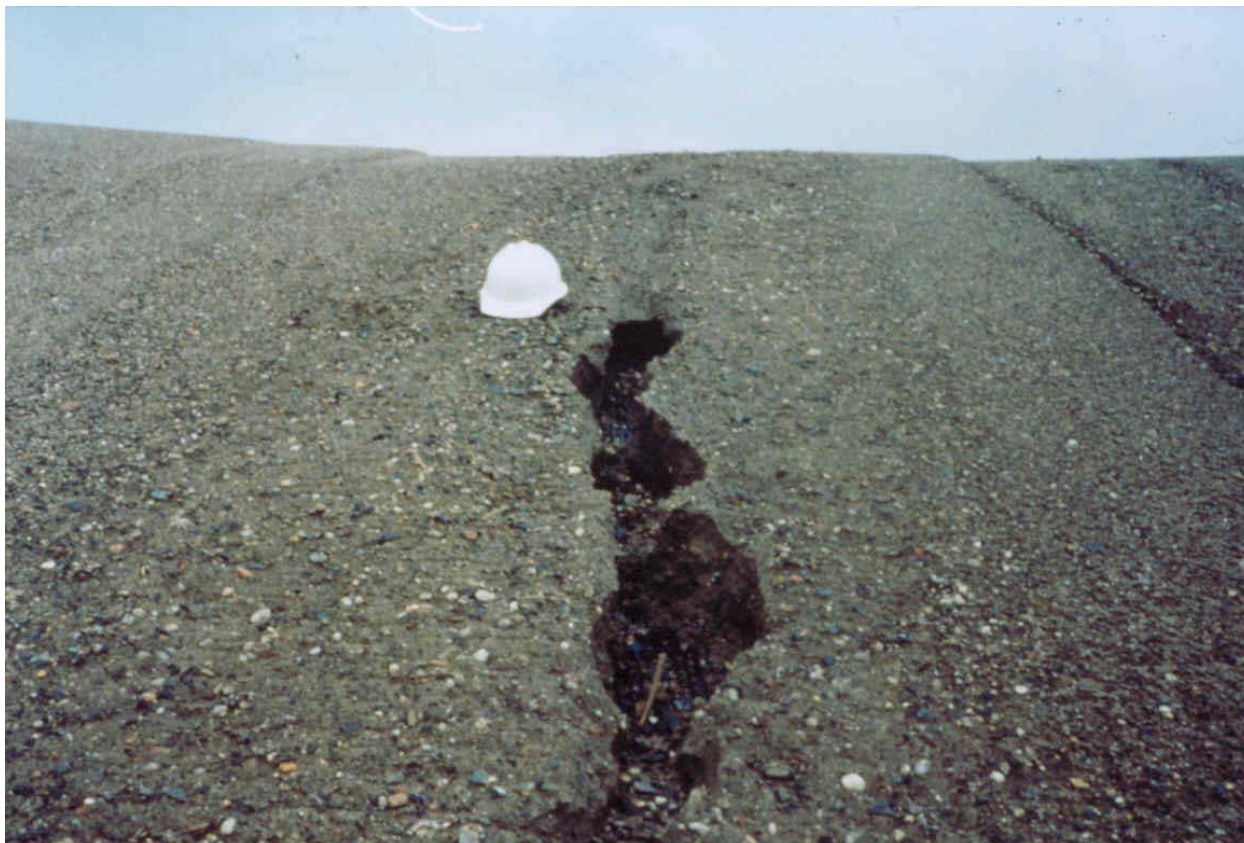
**Figure F-A.2.1. Construction debris in a CCL with an initially smooth surface protruded from the CCL after the CCL was left exposed and subsequently eroded.**
