**RECOMMENDATIONS FOR RISK
ASSESSMENTS OF ICE THROW AND
BLADE FAILURE IN ONTARIO**

Client	Canadian Wind Energy Association
Contact	David Timm
Document No	38079/OR/01
Classification	Client's Discretion
Date	31 May 2007

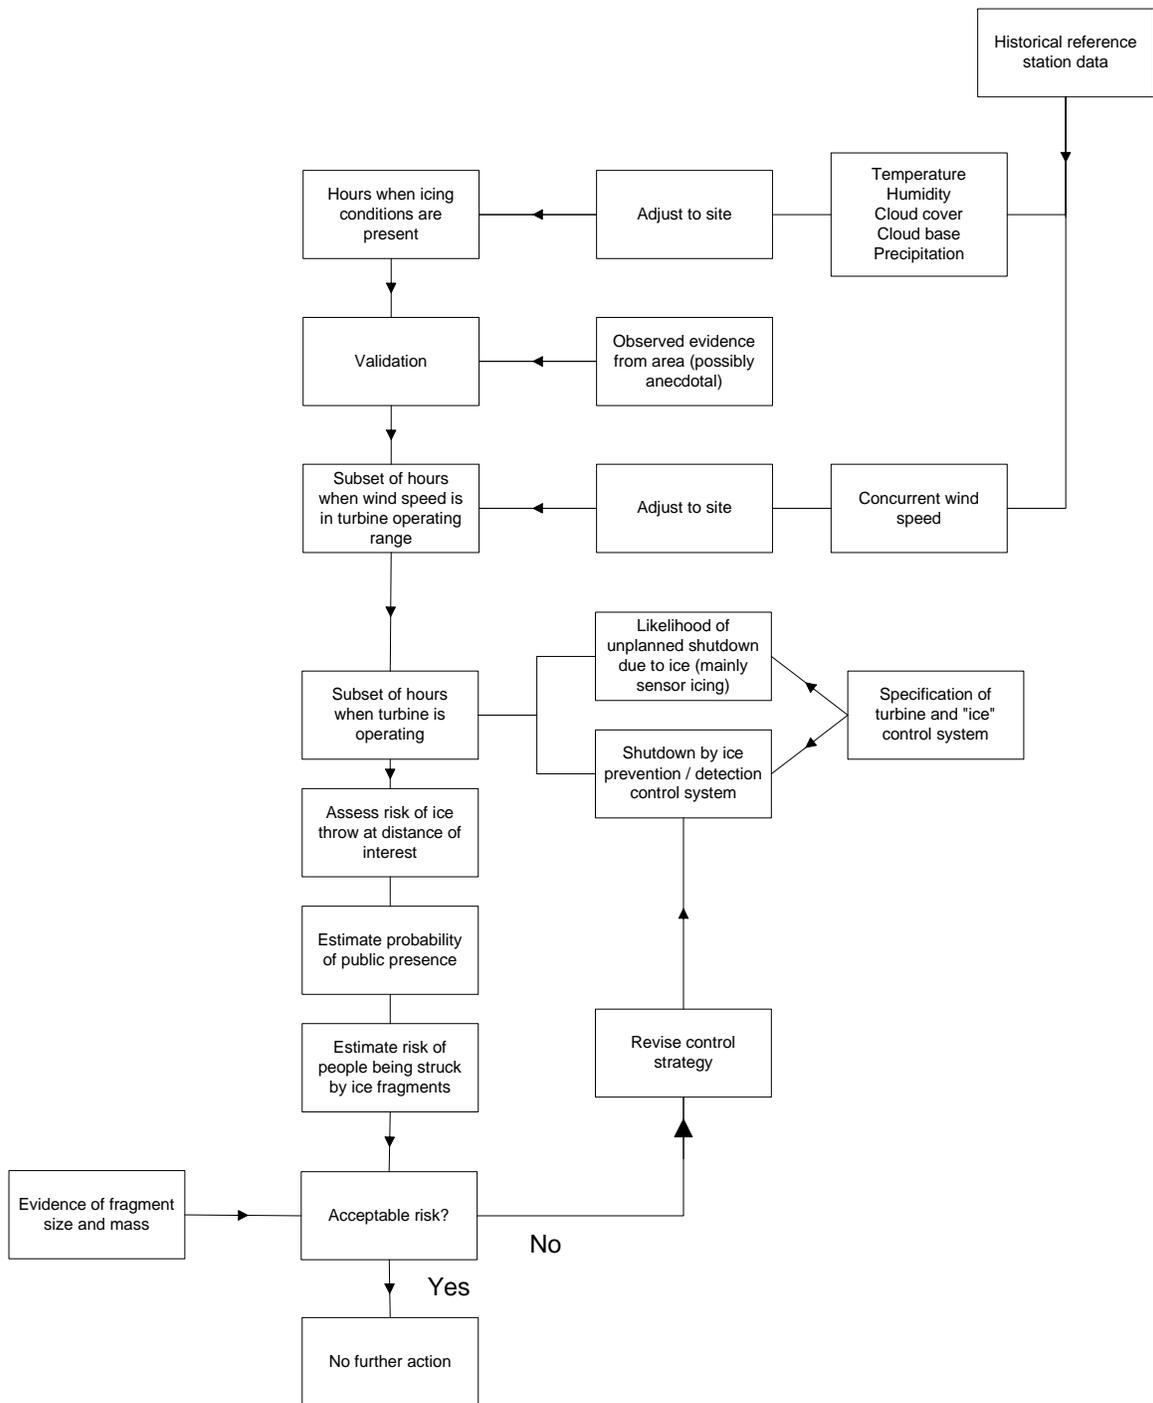
Figure 3.1 Ice throw risk assessment procedure

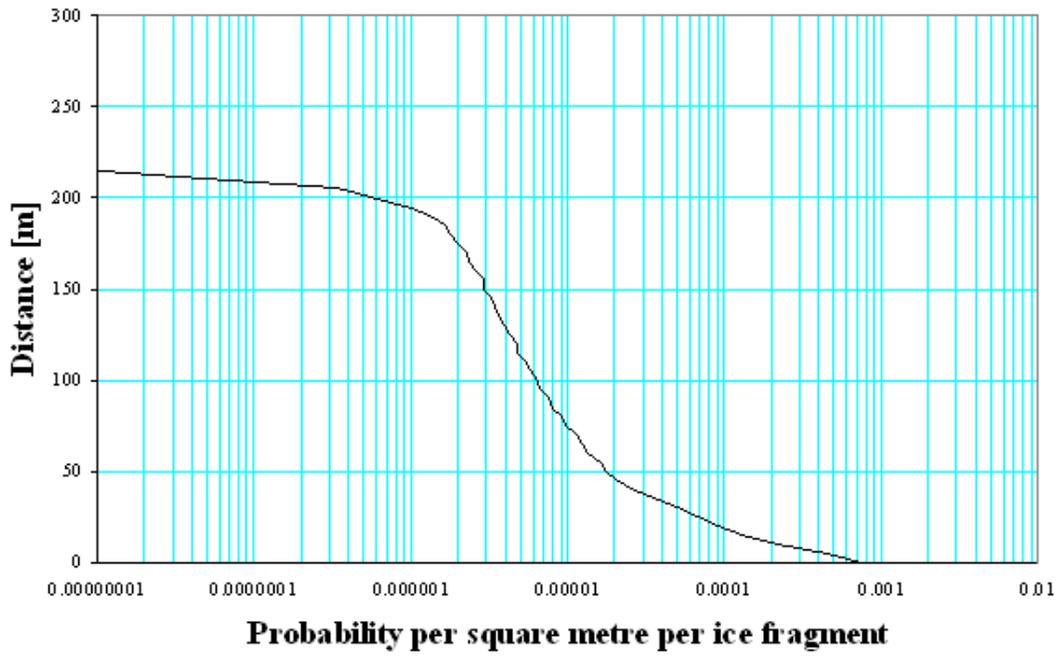
Figure 3.2 Calculated probability of ice fragment throw distances

The results are shown in Figure 3.2. This represents the probability, given an ice fragment has been released, that any one ice fragment lands in one square metre of ground area, as a function of distance from the turbine. Clearly the risk per square metre per year is obtained by multiplying by this probability by the probability of a fragment being released, which in turn depends on the number of ice fragments thrown from the turbine per year.

When considering the results above and assuming three categories of icing conditions for this Ontario study, the chart in Figure 3.4 is proposed for use in risk assessment where detailed assessment is required. It will be noted that the critical distance of 220 m referred to above is significantly exceeded in the data presented in Figure 3.4. The curves provided for distances in excess of 250 m have been included on a pragmatic basis to add a level of conservatism at low probability values and are not based purely on the data presented in Figure 3.2.

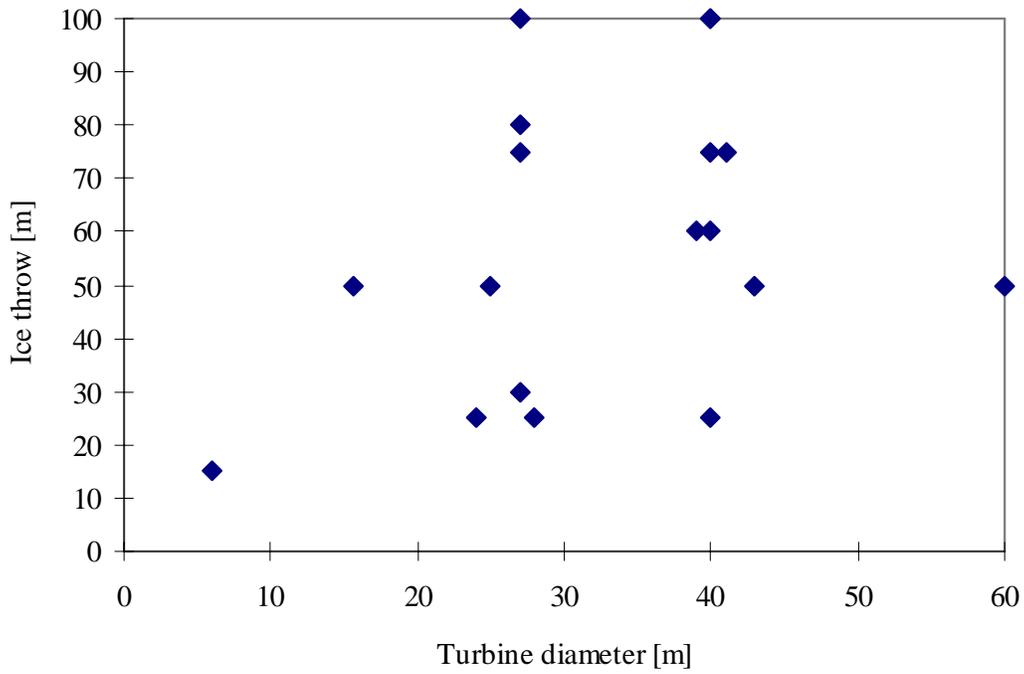
Figure 3.3 Recorded ice throw data (from [3.4])

In the EU WECO study [3.4], the observations of ice build-up on rotor blades and fragments shed from rotor blades were gathered from wind farms throughout Europe. The data gathered are presented in Figure 3.3, which shows that fragments typically land within 100 m of the wind turbine. Ice fragments with masses up to 1 kg were found although most were much smaller.

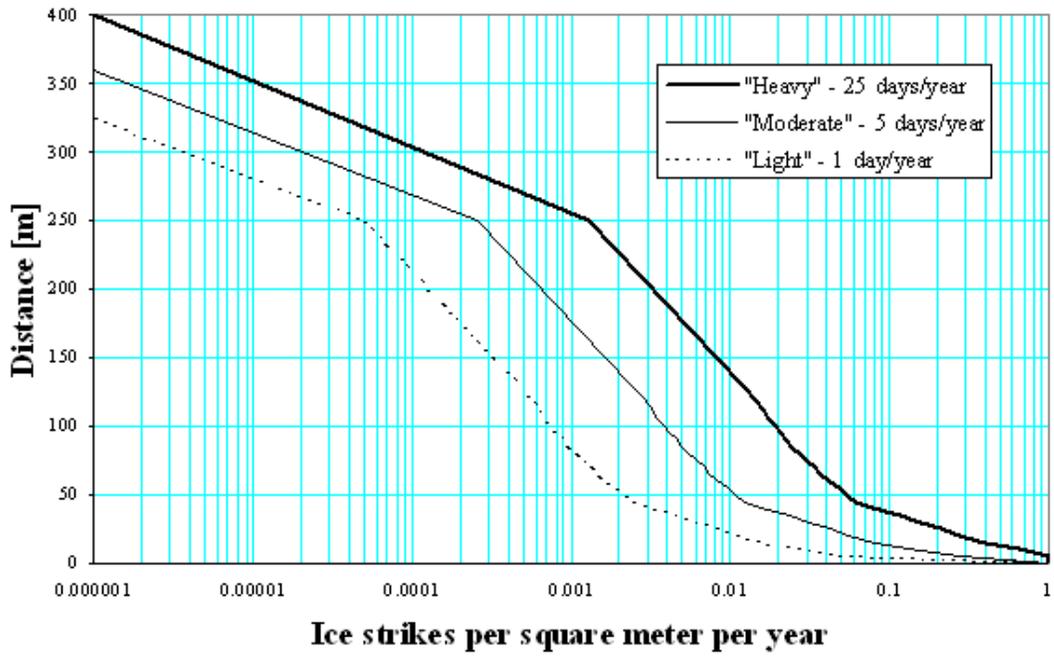
Figure 3.4 Recommended probability for ice fragment strikes in Ontario

- From Figure 3.4 for moderate icing conditions, the risk profile on the road can be plotted as presented in Figure 3.8.
- It is assumed in a rural setting that 100 vehicles traveling at 60 kilometer per hour will pass the turbine during the 5 days of icing events. From Figure 3.8, a vehicle would be exposed to hazard for a conservative 600 m segment of the road. Therefore, the fraction of time that a vehicle would be exposed to hazard is:

- From Figure 3.4 for moderate icing conditions, the risk profile for distances between 50 m and 300 m can be obtained.
- Given that the area between 300 m and 50 m is approximately 275,000 m² and calculating the distance weighted area under the 50 m to 300 m risk profile, the resulting IR probability for an individual with a plan area of 1 m² would be:

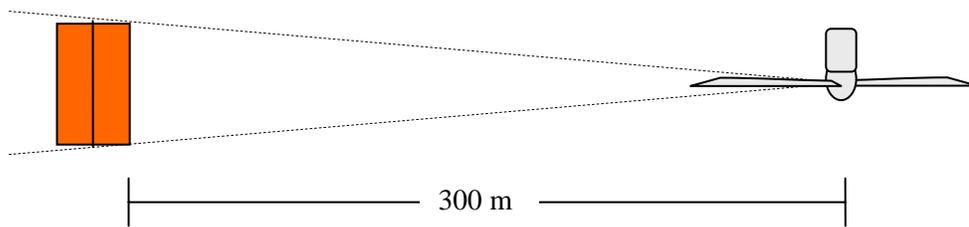
Figure 3.5 Scenario A – Fixed dwelling

For the purpose of the example calculations, the sites for all three scenarios are represented by the assumptions listed above. Moderate icing conditions (5 days per year) in flat open terrain have been assumed. The relevant distances for each scenario are presented in Figures 3.5 to 3.7. It is also assumed that there are no mitigation strategies as discussed Section 5 in place to prevent an ice throw event from occurring.

In this scenario, a 100 m² dwelling is situated at a distance of 300 m from a turbine, see Figure 3.5. Based on the general assumptions, the following calculation can be made:

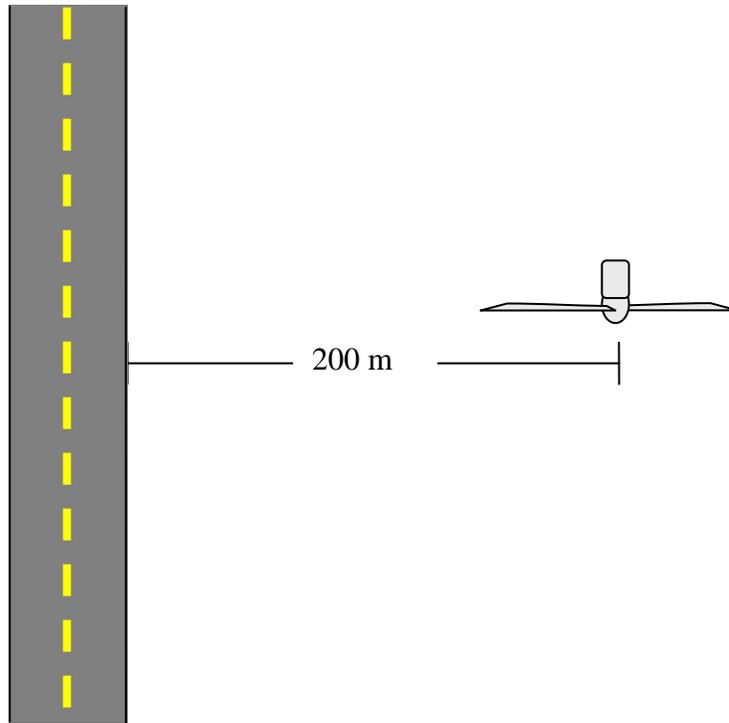
Figure 3.6 Scenario B - Road

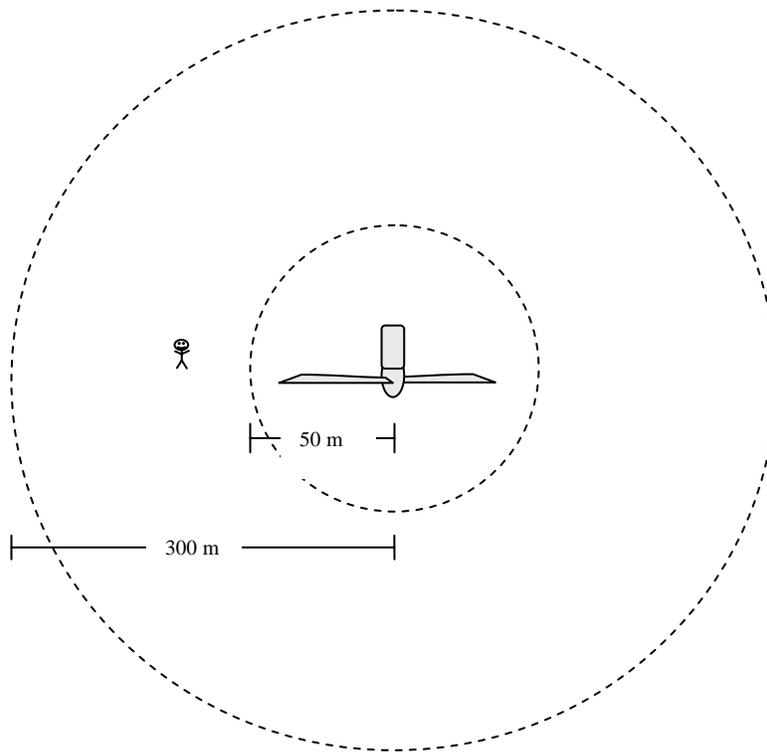
Figure 3.7 Scenario C - Individual

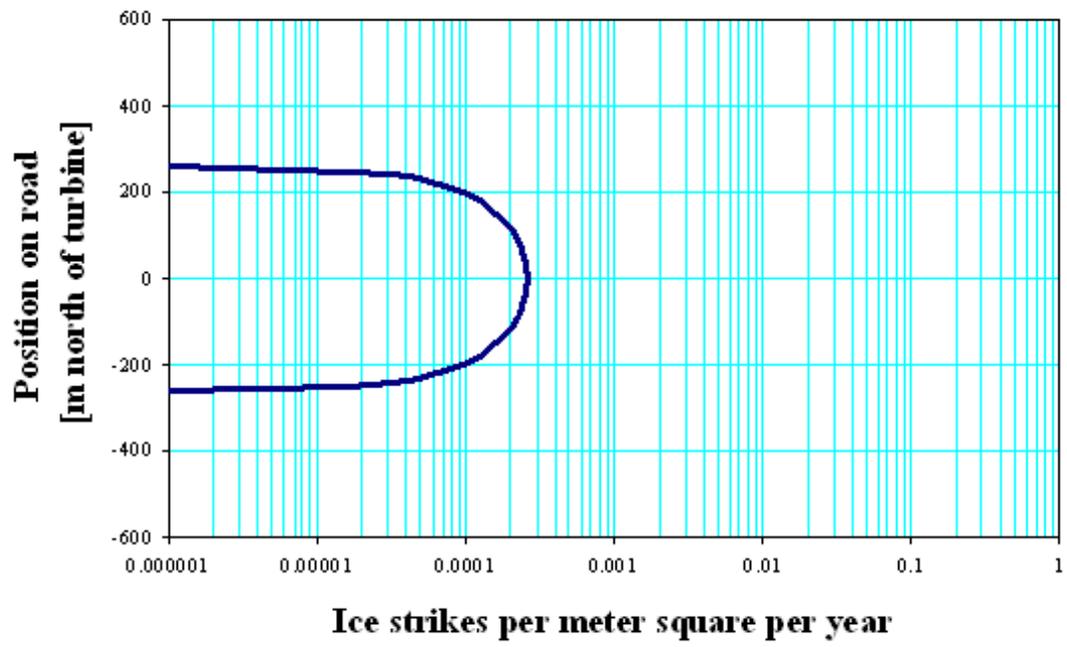
Figure 3.8 Risk profile for Scenario B

- Calculating the area weighted average under the risk profile of Figure 3.8 and assuming that wind directions resulting in a turbine rotor alignment with the road occur 80% of the time during icing conditions, the resulting IR for a vehicle with a plan area of 10 m² would be:
